## PRE-DEMOLITION ASBESTOS SURVEY REPORT

### Former Goodwill Building

303 S. Main Street

**Project Number:** 26-232-0425

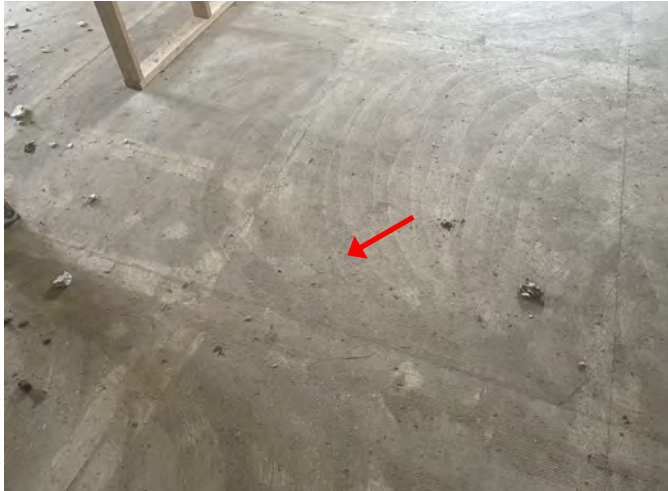
Photograph 1

| HA ID # | Material | Description | Locations of Material | *Friable or Non-Friable | *NESHAP Category | Sample Numbers Collected | Photo # | Laboratory Results | Asbestos Determination | Estimated Quantity* |
|---|---|---|---|---|---|---|---|---|---|---|
| 1 | Residual Mastic | Yellow Floor Mastic | 1st Floor, Throughout Most Areas | Not Applicable | Not Applicable | 1-1<br>1-2** | 1 | No Asbestos Detected | Non-ACM | Not Applicable |

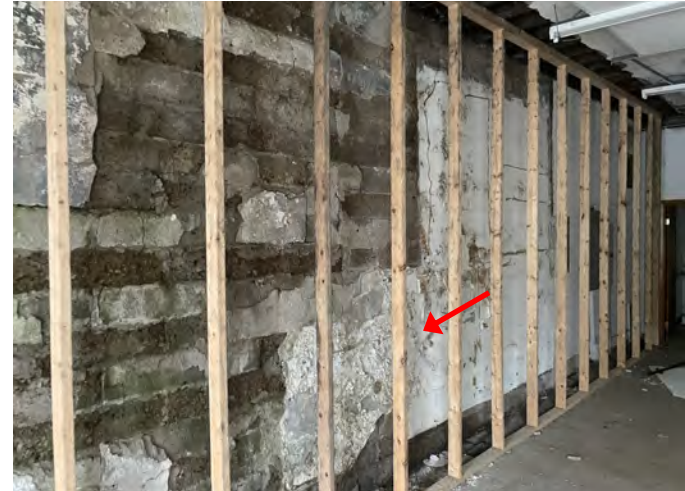
Photograph 2

| HA ID # | Material | Description | Locations of Material | *Friable or Non-Friable | *NESHAP Category | Sample Numbers Collected | Photo # | Laboratory Results | Asbestos Determination | Estimated Quantity* |
|---|---|---|---|---|---|---|---|---|---|---|
| 2 | Hard Plaster | Hard Plaster (White Skim Coat over Gray Base Coat) | Throughout Building | Not Applicable | Not Applicable | 2-1<br>2-2<br>2-3<br>2-4<br>2-5<br>2-6<br>2-7<br>2-8<br>2-9** | 2 | No Asbestos Detected | Non-ACM | Not Applicable |

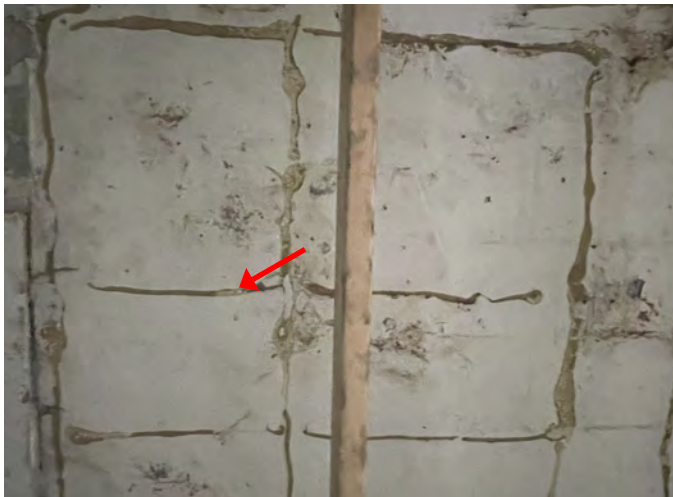
Photograph 3

| HA ID # | Material | Description | Locations of Material | *Friable or Non-Friable | *NESHAP Category | Sample Numbers Collected | Photo # | Laboratory Results | Asbestos Determination | Estimated Quantity* |
|---|---|---|---|---|---|---|---|---|---|---|
| 3 | Construction Adhesive | Dark Tan Construction Adhesive | 1st Floor, South Side, West Wall, East of Restrooms | Not Applicable | Not Applicable | 3-1<br>3-2 | 3 | No Asbestos Detected | Non-ACM | Not Applicable |

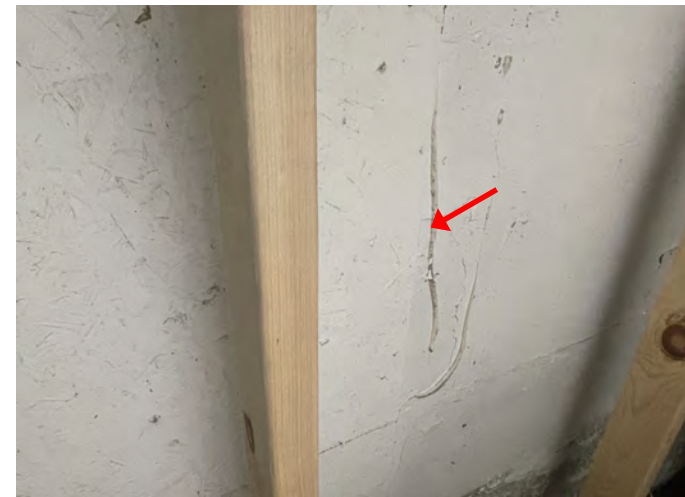
Photograph 4

| HA ID # | Material | Description | Locations of Material | *Friable or Non-Friable | *NESHAP Category | Sample Numbers Collected | Photo # | Laboratory Results | Asbestos Determination | Estimated Quantity* |
|---|---|---|---|---|---|---|---|---|---|---|
| 4 | Construction Adhesive | White to Gray Construction Adhesive | 1st Floor South Side, South Wall, West of Restrooms | Not Applicable | Not Applicable | 4-1<br>4-2 | 4 | No Asbestos Detected | Non-ACM | Not Applicable |

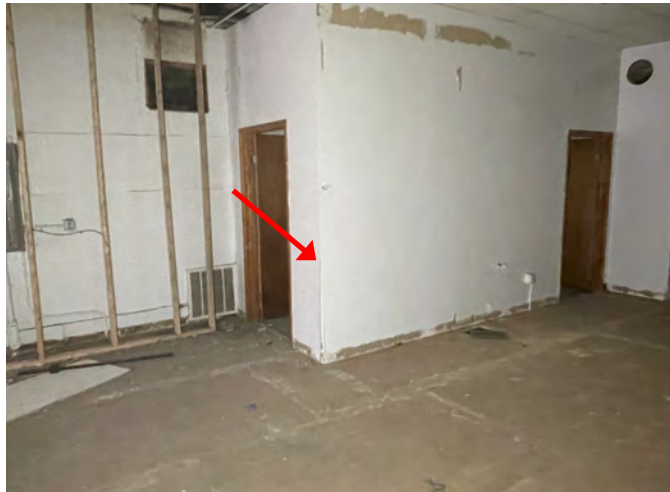
Photograph 5

| HA ID # | Material | Description | Locations of Material | *Friable or Non-Friable | *NESHAP Category | Sample Numbers Collected | Photo # | Laboratory Results | Asbestos Determination | Estimated Quantity* |
|---|---|---|---|---|---|---|---|---|---|---|
| 5 | Drywall System | White Drywall Board with White Joint Compound | Various Locations Throughout 1st Floor | Not Applicable | Not Applicable | 5-1<br>5-2<br>5-3<br>5-4<br>5-5 | 5 | No Asbestos Detected | Non-ACM | Not Applicable |

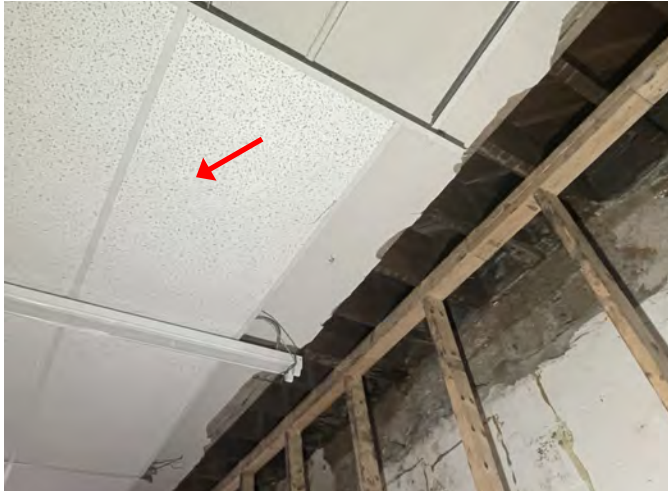
Photograph 9

| HA ID # | Material | Description | Locations of Material | *Friable or Non-Friable | *NESHAP Category | Sample Numbers Collected | Photo # | Laboratory Results | Asbestos Determination | Estimated Quantity* |
|---|---|---|---|---|---|---|---|---|---|---|
| 9 | Ceiling Tile | 2' x 4' Suspended Ceiling Tile (Random Small Fissures and Holes) | Throughout Most of the 1st Floor | Not Applicable | Not Applicable | 9-1<br>9-2<br>9-3 | 9 | No Asbestos Detected | Non-ACM | Not Applicable |
