## Limited Lead-Based Paint Sampling Report

**Former Marysville Water Plant**  
**409 N. Main Street**  
**Marysville, Ohio 43040**

**Report Date: June 20, 2023**  
**Project Number: 23-232-004**

**Re: Limited Lead Sampling Report  
Former Marysville Water Plant  
409 N. Main Street  
Marysville, Ohio 43040  
DET Project Number: 23-232-004**

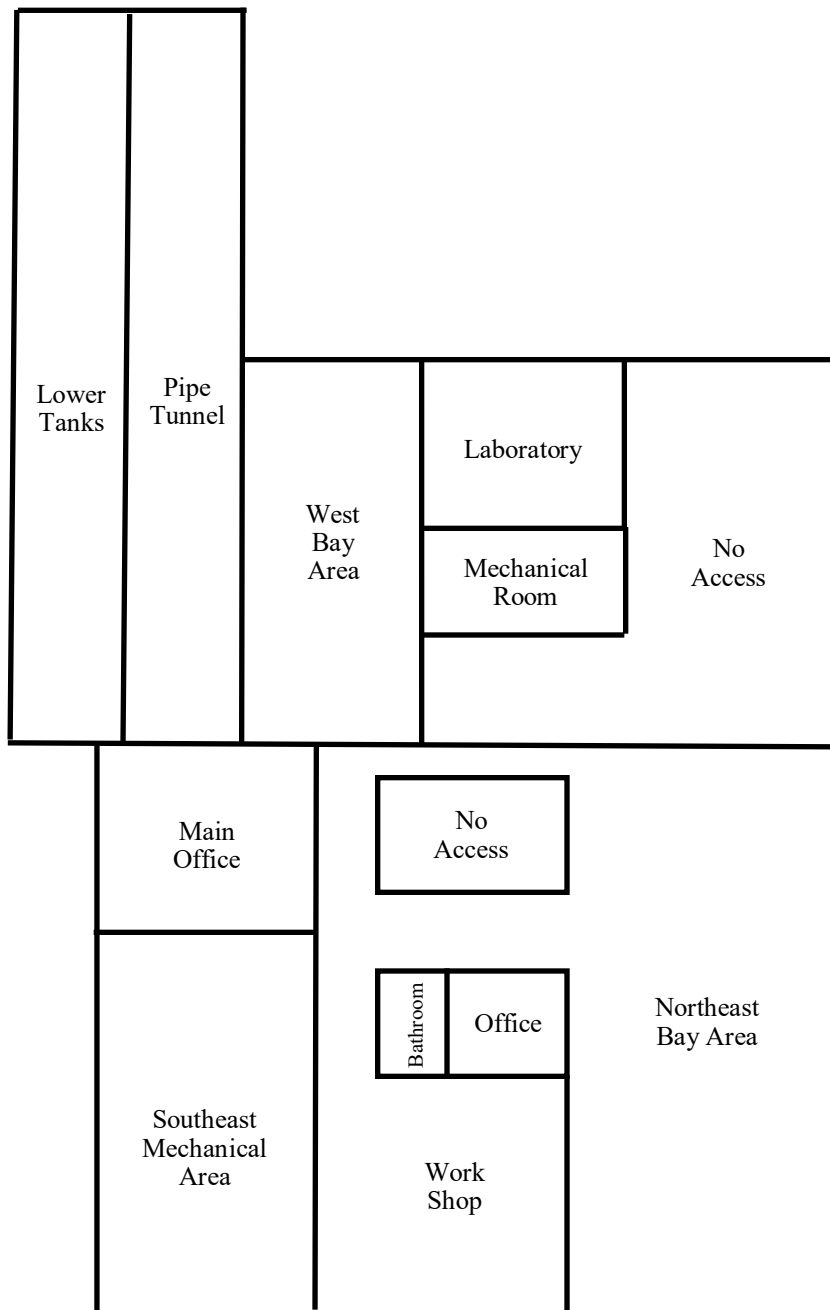
Individual room names are depicted on building floor plans provided in Attachment A. Side allocation of walls within each room equivalent are identified as either "A, B, C or D", based on the orientation to the side of the building facing N. Main Street. The wall closest and parallel to N. Main Street was identified as Wall A. Facing the building from N. Main Street, Walls B, C, and D are identified clockwise from Wall A.
