## Limited Asbestos Sampling Report

**Marysville Water Plant**  
409 N. Main Street  
Marysville, Ohio 43040

**Report Date: June 19, 2023**  
**Project Number: 23-232-004**

**Re: Limited Asbestos Sampling Report  
Marysville Water Plant  
409 N. Main Street  
Marysville, Ohio 43040**

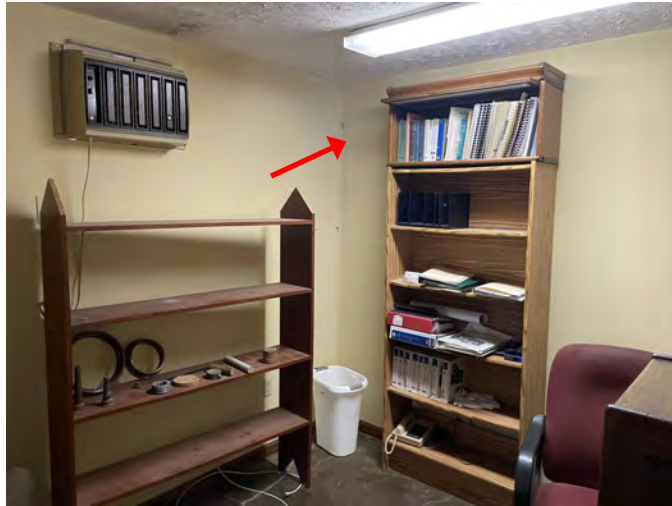
Photograph 1

| HA ID # | Material | Description | Locations of Material | *Friable or Non-Friable | *NESHAP Category | Sample Numbers Collected | Photo # | Laboratory Results | Asbestos Determination | Estimated Quantity |
|---|---|---|---|---|---|---|---|---|---|---|
| 1 | Drywall Board and Joint Compound | White Drywall Board with White Joint Compound | Various Locations Throughout Building | Non-Friable | Not Applicable | 1-1<br>1-2<br>1-3<br>1-4<br>1-5 | 1 | No Asbestos Detected | Non-ACM | Not Applicable |

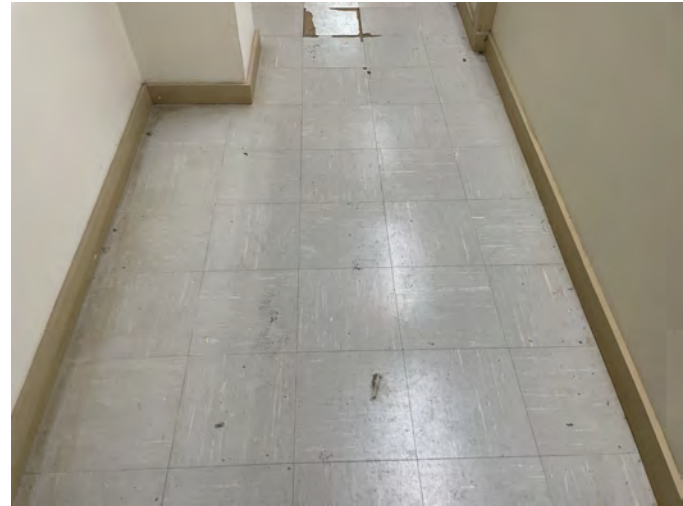
Photograph 2

| HA ID # | Material | Description | Locations of Material | *Friable or Non-Friable | *NESHAP Category | Sample Numbers Collected | Photo # | Laboratory Results | Asbestos Determination | Estimated Quantity |
|---|---|---|---|---|---|---|---|---|---|---|
| 2 | Floor Tile and Mastic | 12" x 12" Light Gray with Tan Streaks Floor Tile and Yellow Mastic | Main Office | Non-Friable | Not Applicable | 2-1<br>2-2 | 2 | No Asbestos Detected | Non-ACM | Not Applicable |

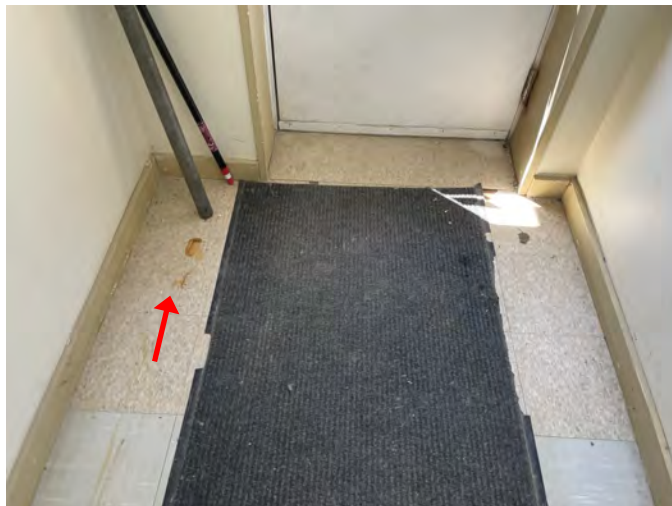
Photograph 3

| HA ID # | Material | Description | Locations of Material | *Friable or Non-Friable | *NESHAP Category | Sample Numbers Collected | Photo # | Laboratory Results | Asbestos Determination | Estimated Quantity |
|---|---|---|---|---|---|---|---|---|---|---|
| 3 | Floor Tile and Mastic | 12" x 12" Brown Mottled Floor Tile with Yellow Mastic | Main Office, Patch Area Near South Door | Non-Friable | Not Applicable | 3-1<br>3-2 | 3 | No Asbestos Detected | Non-ACM | Not Applicable |

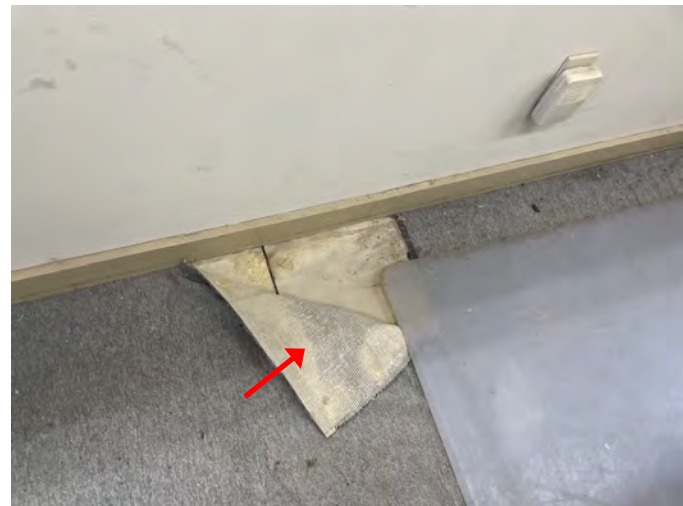
Photograph 4

| HA ID # | Material | Description | Locations of Material | *Friable or Non-Friable | *NESHAP Category | Sample Numbers Collected | Photo # | Laboratory Results | Asbestos Determination | Estimated Quantity |
|---|---|---|---|---|---|---|---|---|---|---|
| 4 | Carpet Mastic | Tan Mastic Associated with Carpeting | Main Office and 2nd Floor Office | Non-Friable | Not Applicable | 4-1<br>4-2 | 4 | No Asbestos Detected | Non-ACM | Not Applicable |

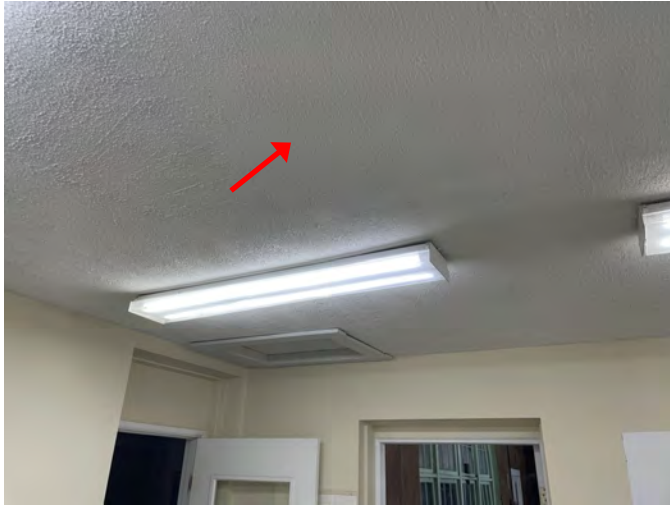
Photograph 5

| HA ID # | Material | Description | Locations of Material | *Friable or Non-Friable | *NESHAP Category | Sample Numbers Collected | Photo # | Laboratory Results | Asbestos Determination | Estimated Quantity |
|---|---|---|---|---|---|---|---|---|---|---|
| 5 | Texture Compound | White Ceiling Texture Compound | Main Office Ceiling | Friable | Not Applicable | 5-1<br>5-2<br>5-3 | 5 | No Asbestos Detected | Non-ACM | Not Applicable (Sampling Less Than 1,000 Square Feet) |

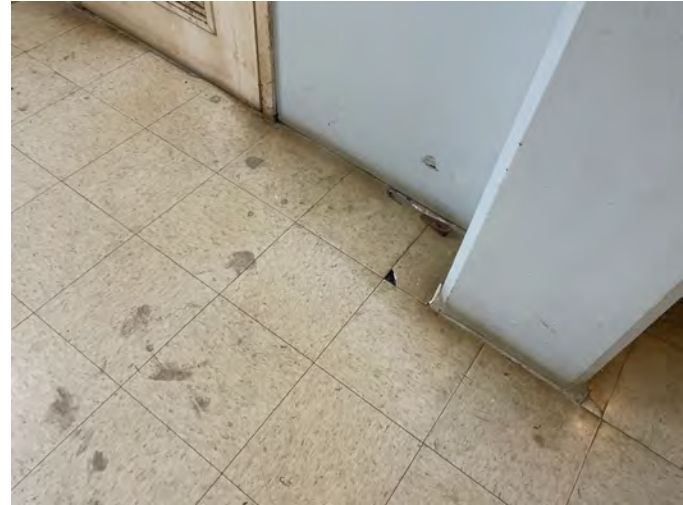
Photograph 6

| HA ID # | Material | Description | Locations of Material | *Friable or Non-Friable | *NESHAP Category | Sample Numbers Collected | Photo # | Laboratory Results | Asbestos Determination | Estimated Quantity |
|---|---|---|---|---|---|---|---|---|---|---|
| 6 | Floor Tile and Mastic | 12" x 12" Tan Mottled Floor Tile and Black Mastic | West Bay Area | Non-Friable | Not Applicable | 6-1<br>6-2 | 6 | No Asbestos Detected | Non-ACM | Not Applicable |

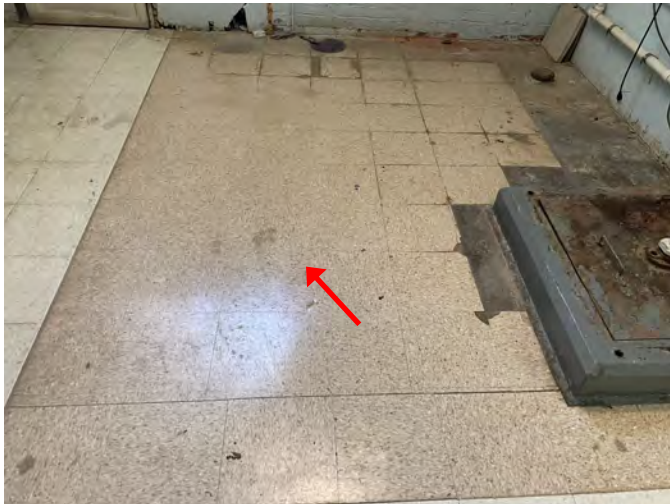
Photograph 7

- 12" x 12" brown mottled floor tile located in the West Bay Area (patched area)

| HA ID # | Material | Description | Locations of Material | *Friable or Non-Friable | *NESHAP Category | Sample Numbers Collected | Photo # | Laboratory Results | Asbestos Determination | Estimated Quantity |
|---|---|---|---|---|---|---|---|---|---|---|
| 7 | Floor Tile and Mastic | 12" x 12" Brown Mottled Floor Tile with Brown Mastic | West Bay Area, Northwest Patch Area | Non-Friable | Category I Non-Friable | 7-1<br>7-2 | 7 | Tile = 2% Chrysotile Asbestos<br>Mastic = No Asbestos Detected | ACM | 80 Square Feet |

ACM identified during this assessment should only be removed by an Ohio-licensed Asbestos Hazard Abatement Contractor.

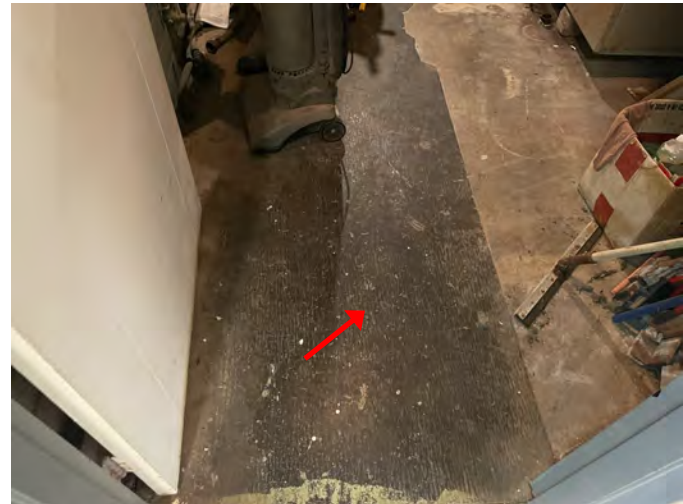
Photograph 8

| HA ID # | Material | Description | Locations of Material | *Friable or Non-Friable | *NESHAP Category | Sample Numbers Collected | Photo # | Laboratory Results | Asbestos Determination | Estimated Quantity |
|---|---|---|---|---|---|---|---|---|---|---|
| 8 | Sheet Flooring and Mastic | Black Sheet Flooring and Brown Mastic | Mechanical Room (Near Laboratory) | Non-Friable | Not Applicable | 8-1<br>8-2 | 8 | No Asbestos Detected | Non-ACM | Not Applicable |

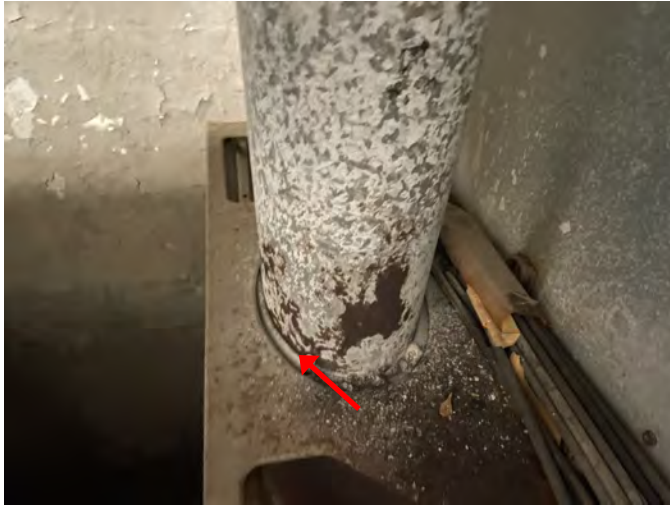
Photograph 9

| HA ID # | Material | Description | Locations of Material | *Friable or Non-Friable | *NESHAP Category | Sample Numbers Collected | Photo # | Laboratory Results | Asbestos Determination | Estimated Quantity |
|---|---|---|---|---|---|---|---|---|---|---|
| 9 | Flue Cement | Gray Flue Cement | Mechanical Room (Near Laboratory) | Non-Friable | Not Applicable | 9-1<br>9-2 | 9 | No Asbestos Detected | Non-ACM | Not Applicable |

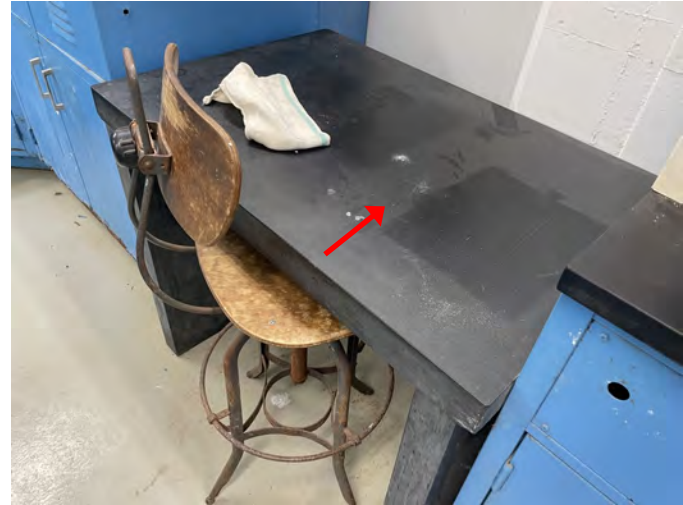
Photograph 10

| HA ID # | Material | Description | Locations of Material | *Friable or Non-Friable | *NESHAP Category | Sample Numbers Collected | Photo # | Laboratory Results | Asbestos Determination | Estimated Quantity |
|---|---|---|---|---|---|---|---|---|---|---|
| 10 | Desktop | Black Desktop and Sides | Laboratory | Non-Friable | Not Applicable | 10-1<br>10-2 | 10 | No Asbestos Detected | Non-ACM | Not Applicable |

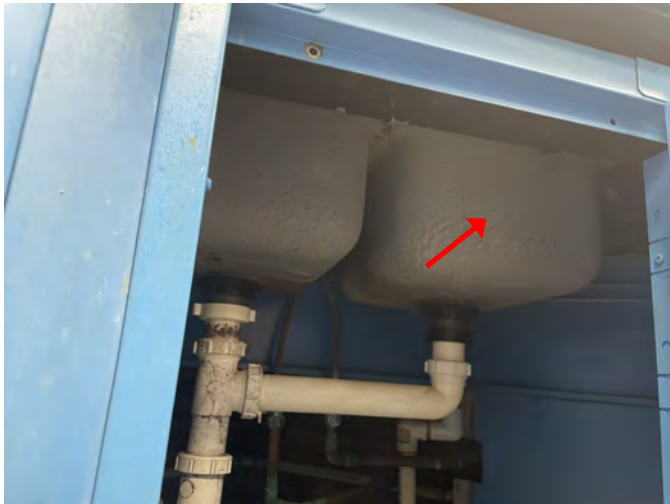
Photograph 11

| HA ID # | Material | Description | Locations of Material | *Friable or Non-Friable | *NESHAP Category | Sample Numbers Collected | Photo # | Laboratory Results | Asbestos Determination | Estimated Quantity |
|---|---|---|---|---|---|---|---|---|---|---|
| 11 | Sink Undercoating | Gray Sink Undercoating | Laboratory | Non-Friable | Not Applicable | 11-1<br>11-2 | 11 | No Asbestos Detected | Non-ACM | Not Applicable |

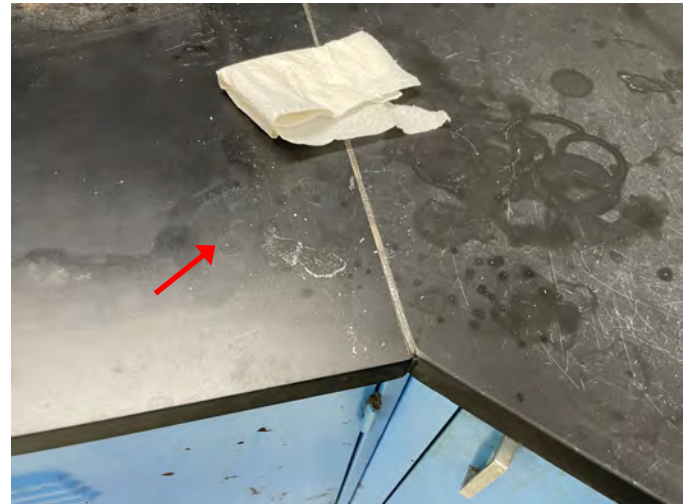
Photograph 12

| HA ID # | Material | Description | Locations of Material | *Friable or Non-Friable | *NESHAP Category | Sample Numbers Collected | Photo # | Laboratory Results | Asbestos Determination | Estimated Quantity |
|---|---|---|---|---|---|---|---|---|---|---|
| 12 | Laboratory Counters | Black Laboratory Countertop, Backsplash, and Drywall Rack | Laboratory | Non-Friable | Not Applicable | 12-1<br>12-2 | 12 | No Asbestos Detected | Non-ACM | Not Applicable |

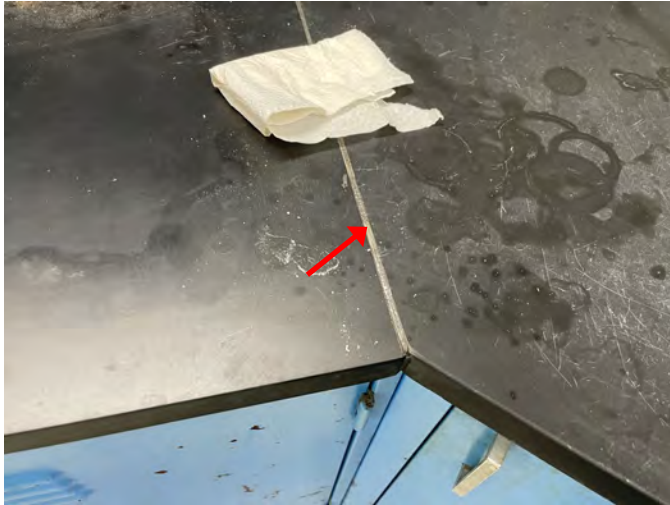
Photograph 13

| HA ID # | Material | Description | Locations of Material | *Friable or Non-Friable | *NESHAP Category | Sample Numbers Collected | Photo # | Laboratory Results | Asbestos Determination | Estimated Quantity |
|---|---|---|---|---|---|---|---|---|---|---|
| 13 | Filler | Black Seam Filler Associated with Laboratory Countertop | Laboratory | Non-Friable | Not Applicable | 13-1<br>13-2 | 13 | No Asbestos Detected | Non-ACM | Not Applicable |

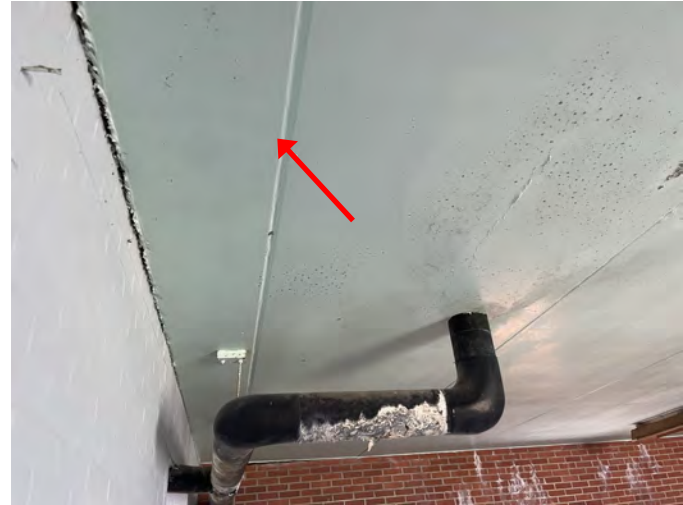
Photograph 14

| HA ID # | Material | Description | Locations of Material | *Friable or Non-Friable | *NESHAP Category | Sample Numbers Collected | Photo # | Laboratory Results | Asbestos Determination | Estimated Quantity |
|---|---|---|---|---|---|---|---|---|---|---|
| 14 | Caulking | Tan Rubbery Caulking Associated with Concrete Ceiling Joints | 2nd Floor, Southwest Most Upper Tank Area | Non-Friable | Not Applicable | 14-1<br>14-2 | 14 | No Asbestos Detected | Non-ACM | Not Applicable |

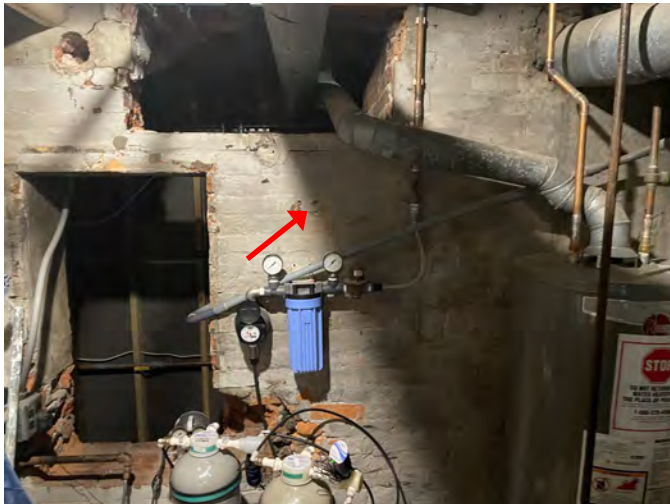
Photograph 15

| HA ID # | Material | Description | Locations of Material | *Friable or Non-Friable | *NESHAP Category | Sample Numbers Collected | Photo # | Laboratory Results | Asbestos Determination | Estimated Quantity |
|---|---|---|---|---|---|---|---|---|---|---|
| 15 | Paint | Silver Paint | Mechanical Room (Near Laboratory) | Non-Friable | Not Applicable | 15-1<br>15-2 | 15 | No Asbestos Detected | Non-ACM | Not Applicable |

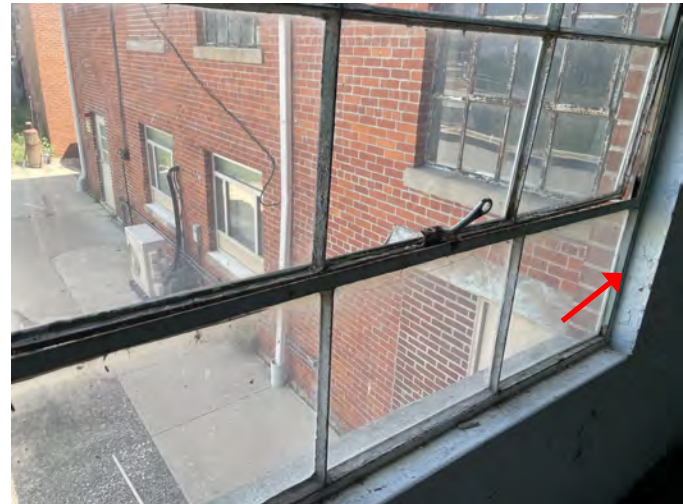
Photograph 16

| HA ID # | Material | Description | Locations of Material | *Friable or Non-Friable | *NESHAP Category | Sample Numbers Collected | Photo # | Laboratory Results | Asbestos Determination | Estimated Quantity |
|---|---|---|---|---|---|---|---|---|---|---|
| 16 | Caulking and Mortar | White Caulking and Gray Mortar Associated with Steel Window Frames | Various Windows, South Building | Non-Friable | Not Applicable | 16-1<br>16-2 | 16 | No Asbestos Detected | Non-ACM | Not Applicable |

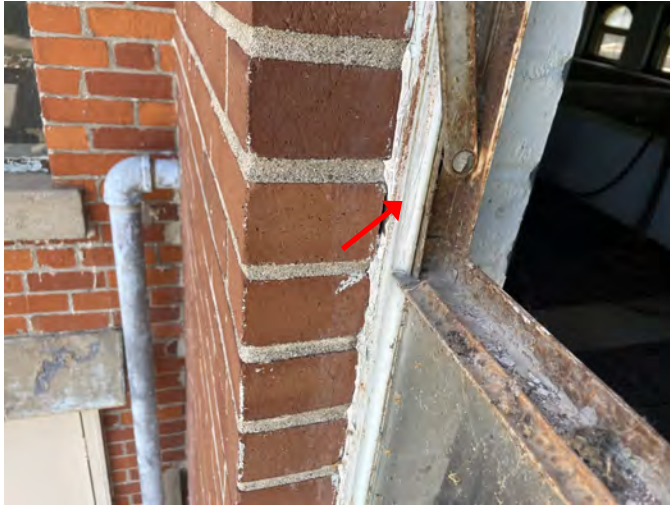
Photograph 17

| HA ID # | Material | Description | Locations of Material | *Friable or Non-Friable | *NESHAP Category | Sample Numbers Collected | Photo # | Laboratory Results | Asbestos Determination | Estimated Quantity |
|---|---|---|---|---|---|---|---|---|---|---|
| 17 | Caulking | White Caulking Associated with Steel Window Frames | Various Windows, South Building | Non-Friable | Not Applicable | 17-1<br>17-2 | 17 | No Asbestos Detected | Non-ACM | Not Applicable |

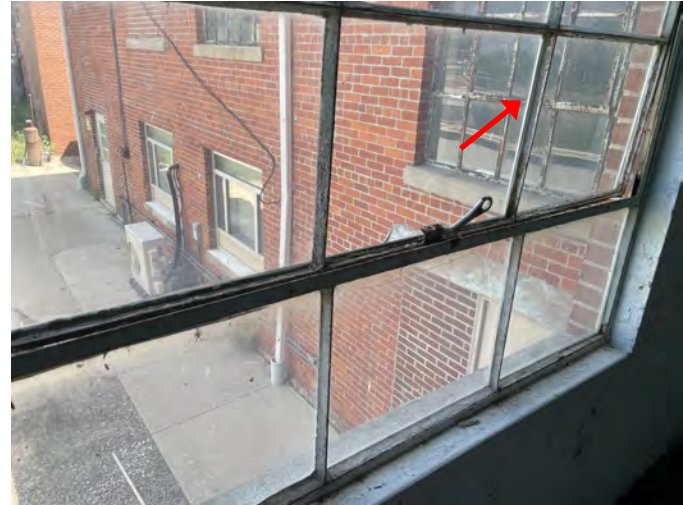
Photograph 18

| HA ID # | Material | Description | Locations of Material | *Friable or Non-Friable | *NESHAP Category | Sample Numbers Collected | Photo # | Laboratory Results | Asbestos Determination | Estimated Quantity |
|---|---|---|---|---|---|---|---|---|---|---|
| 18 | Window Glazing Compound | Gray Window Glazing Compound | Various Windows, South Building | Friable | Not Applicable | 18-1<br>18-2 | 18 | No Asbestos Detected | Non-ACM | Not Applicable |

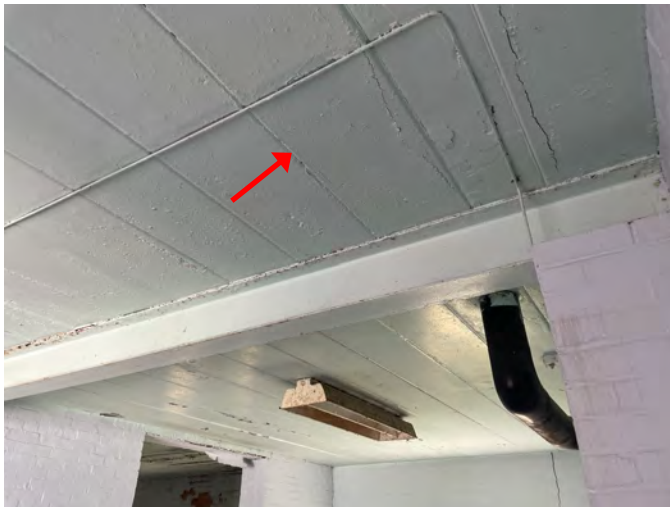
Photograph 19

| HA ID # | Material | Description | Locations of Material | *Friable or Non-Friable | *NESHAP Category | Sample Numbers Collected | Photo # | Laboratory Results | Asbestos Determination | Estimated Quantity |
|---|---|---|---|---|---|---|---|---|---|---|
| 19 | Caulking | Tan Caulking Associated with Concrete Ceiling Joints | 2nd Floor, Southwest Middle Upper Tank Area | Non-Friable | Not Applicable | 19-1<br>19-2 | 19 | No Asbestos Detected | Non-ACM | Not Applicable |

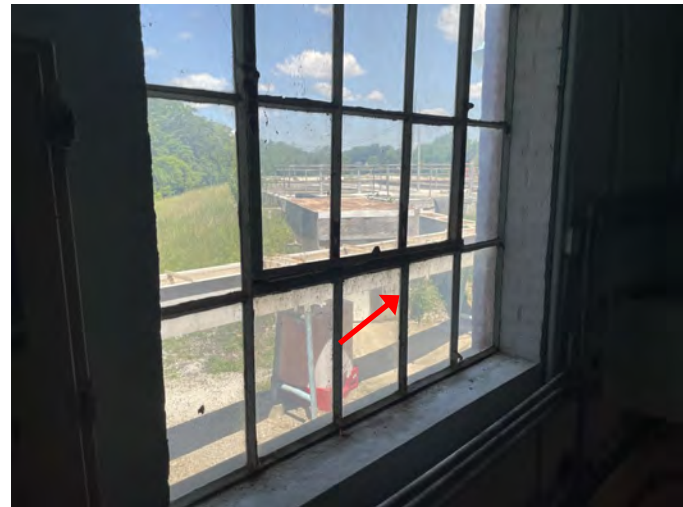
Photograph 20

| HA ID # | Material | Description | Locations of Material | *Friable or Non-Friable | *NESHAP Category | Sample Numbers Collected | Photo # | Laboratory Results | Asbestos Determination | Estimated Quantity |
|---|---|---|---|---|---|---|---|---|---|---|
| 20 | Window Glazing Compound | Tan Window Glazing Compound | Various Windows, South Building | Friable | Not Applicable | 20-1<br>20-2 | 20 | No Asbestos Detected | Non-ACM | Not Applicable |

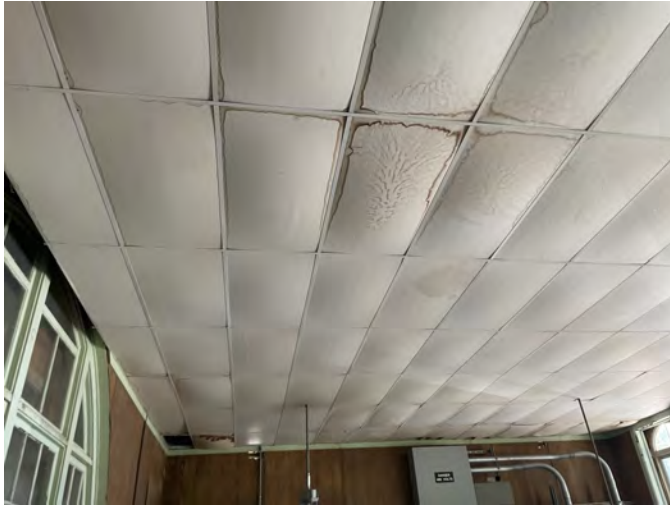
Photograph 21

| HA ID # | Material | Description | Locations of Material | *Friable or Non-Friable | *NESHAP Category | Sample Numbers Collected | Photo # | Laboratory Results | Asbestos Determination | Estimated Quantity |
|---|---|---|---|---|---|---|---|---|---|---|
| 21 | Ceiling Tile | 2' x 4' Ceiling Tile (Brown with White Face) | Southeast Mechanical Room | Friable | Not Applicable | 21-1<br>21-2 | 21 | No Asbestos Detected | Non-ACM | Not Applicable |

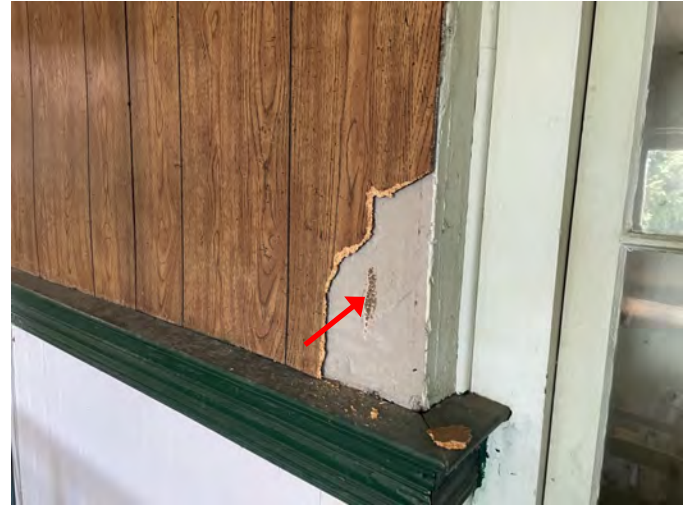
Photograph 22

| HA ID # | Material | Description | Locations of Material | *Friable or Non-Friable | *NESHAP Category | Sample Numbers Collected | Photo # | Laboratory Results | Asbestos Determination | Estimated Quantity |
|---|---|---|---|---|---|---|---|---|---|---|
| 22 | Mastic | Brown Mastic Associated with Wall Paneling | Southeast Mechanical Room | Non-Friable | Not Applicable | 22-1<br>22-2 | 22 | No Asbestos Detected | Non-ACM | Not Applicable |

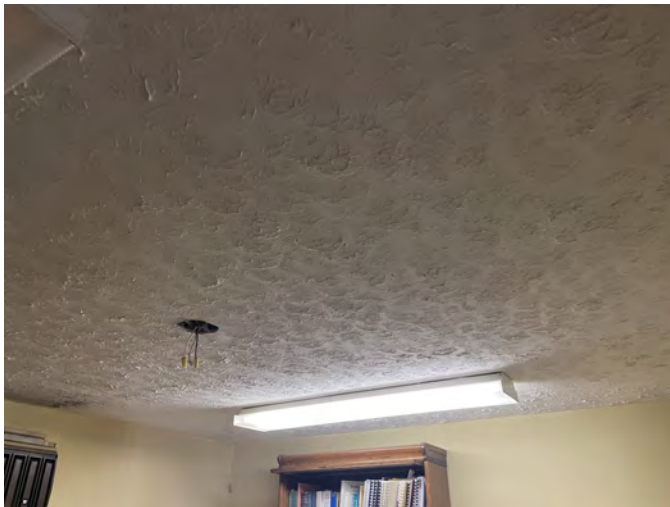
Photograph 23

| HA ID # | Material | Description | Locations of Material | *Friable or Non-Friable | *NESHAP Category | Sample Numbers Collected | Photo # | Laboratory Results | Asbestos Determination | Estimated Quantity |
|---|---|---|---|---|---|---|---|---|---|---|
| 23 | Texture Compound | White Ceiling Texture Compound (Stomp Pattern) | Office (Next to Restroom) | Friable | Not Applicable | 23-1<br>23-2<br>23-3 | 23 | No Asbestos Detected | Non-ACM | Not Applicable (Sampling Less Than 1,000 Square Feet) |

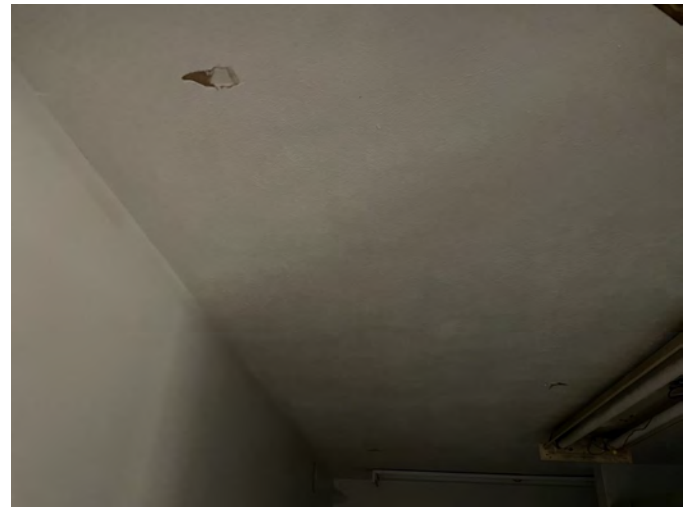
Photograph 24

| HA ID # | Material | Description | Locations of Material | *Friable or Non-Friable | *NESHAP Category | Sample Numbers Collected | Photo # | Laboratory Results | Asbestos Determination | Estimated Quantity |
|---|---|---|---|---|---|---|---|---|---|---|
| 24 | Texture Compound | White Ceiling Texture Compound (Light Texture) | Restroom | Friable | Not Applicable | 24-1<br>24-2<br>24-3 | 24 | No Asbestos Detected | Non-ACM | Not Applicable (Sampling Less Than 1,000 Square Feet) |

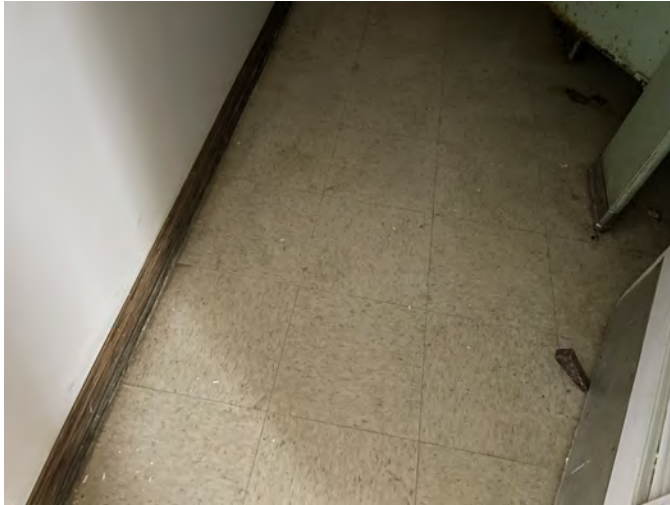
**Photograph 25**

| HA ID # | Material | Description | Locations of Material | *Friable or Non-Friable | *NESHAP Category | Sample Numbers Collected | Photo # | Laboratory Results | Asbestos Determination | Estimated Quantity |
|---|---|---|---|---|---|---|---|---|---|---|
| 25 | Floor Tile and Mastic | 12" x 12" Tan Speckled Floor Tile with Yellow Mastic | Restroom | Non-Friable | Not Applicable | 25-1<br>25-2 | 25 | No Asbestos Detected | Non-ACM | Not Applicable |

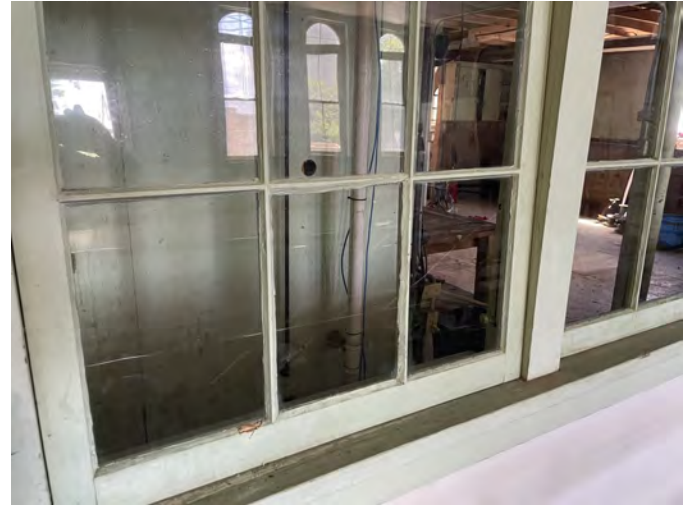
**Photograph 26**

| HA ID # | Material | Description | Locations of Material | *Friable or Non-Friable | *NESHAP Category | Sample Numbers Collected | Photo # | Laboratory Results | Asbestos Determination | Estimated Quantity |
|---|---|---|---|---|---|---|---|---|---|---|
| 26 | Window Glazing Compound | Tan Window Glazing Compound | Windows Between Southeast Mechanical Area and Work Shop | Friable | Not Applicable | 26-1<br>26-2 | 26 | No Asbestos Detected | Non-ACM | Not Applicable |

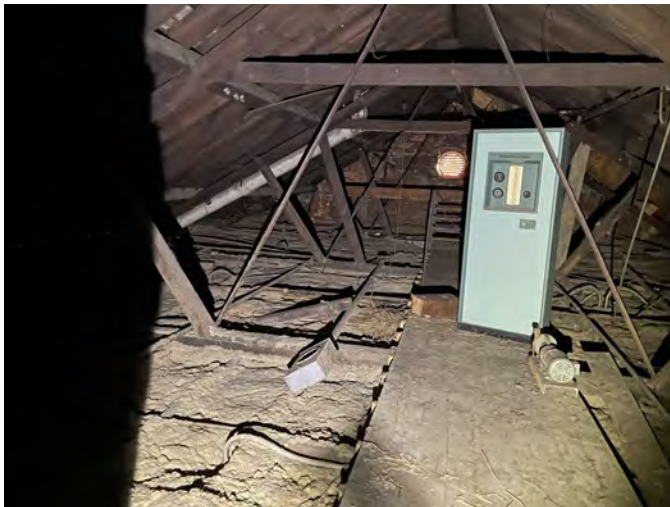
**Photograph 27**

| HA ID # | Material | Description | Locations of Material | *Friable or Non-Friable | *NESHAP Category | Sample Numbers Collected | Photo # | Laboratory Results | Asbestos Determination | Estimated Quantity |
|---|---|---|---|---|---|---|---|---|---|---|
| 27 | Attic Insulation | Gray Attic Insulation (Loose) | Attic | Friable | Not Applicable | 27-1<br>27-2<br>27-3 | 27 | No Asbestos Detected | Non-ACM | Not Applicable |

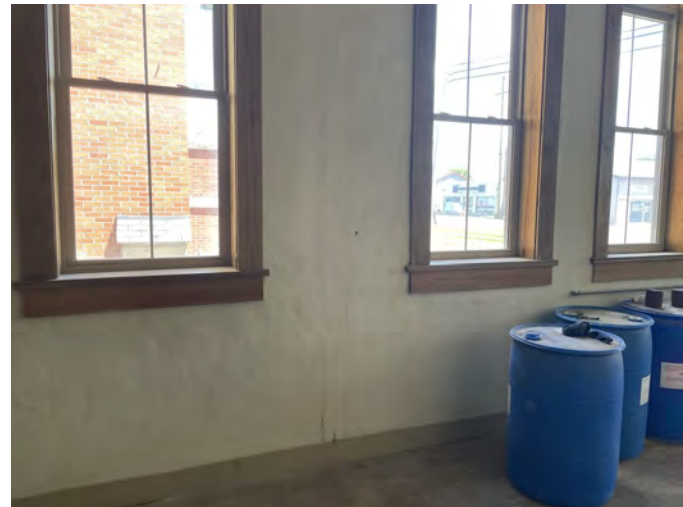
**Photograph 28**

| HA ID # | Material | Description | Locations of Material | *Friable or Non-Friable | *NESHAP Category | Sample Numbers Collected | Photo # | Laboratory Results | Asbestos Determination | Estimated Quantity |
|---|---|---|---|---|---|---|---|---|---|---|
| 28 | Plaster | Hard Plaster (White Finish Coat over Gray Base Coat) | Various Locations Throughout Building | Non-Friable | Not Applicable | 28-1<br>28-2<br>28-3<br>28-4<br>28-5<br>28-6<br>28-7 | 28 | No Asbestos Detected | Non-ACM | Not Applicable (Sampling Area Over 5,000 Square Feet) |

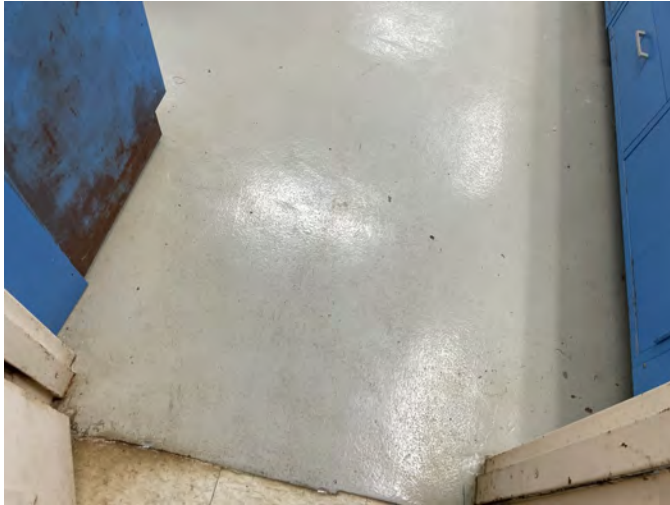
Photograph 29

| HA ID # | Material | Description | Locations of Material | *Friable or Non-Friable | *NESHAP Category | Sample Numbers Collected | Photo # | Laboratory Results | Asbestos Determination | Estimated Quantity |
|---|---|---|---|---|---|---|---|---|---|---|
| 29 | Floor Coating | Gray Floor Coating (Cementitious) | Laboratory | Non-Friable | Not Applicable | 29-1<br>29-2 | 29 | No Asbestos Detected | Non-ACM | Not Applicable |

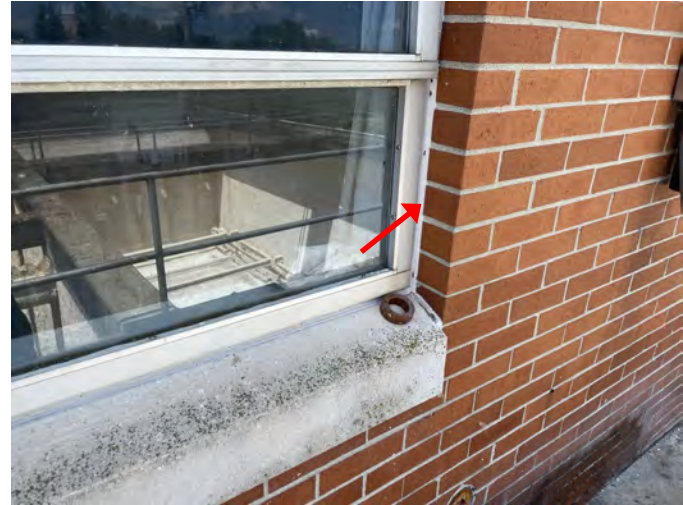
Photograph 30

| HA ID # | Material | Description | Locations of Material | *Friable or Non-Friable | *NESHAP Category | Sample Numbers Collected | Photo # | Laboratory Results | Asbestos Determination | Estimated Quantity |
|---|---|---|---|---|---|---|---|---|---|---|
| 30 | Caulking | Gray Window and Door Frame Caulking | Various Doors and Windows of North Building | Non-Friable | Not Applicable | 30-1<br>30-2 | 30 | No Asbestos Detected | Non-ACM | Not Applicable |

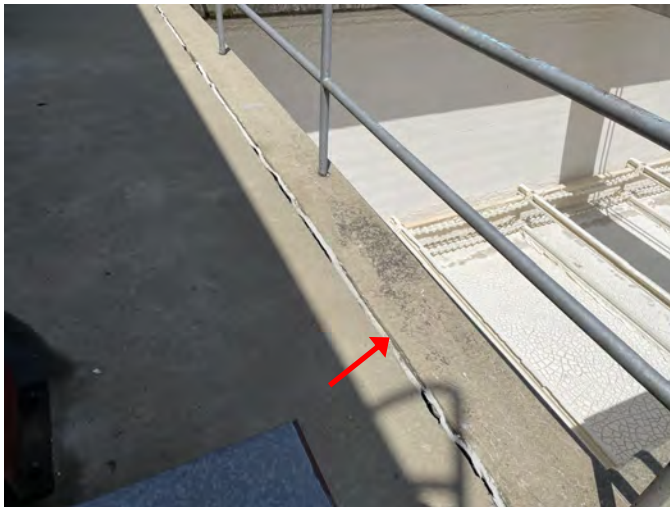
Photograph 31

| HA ID # | Material | Description | Locations of Material | *Friable or Non-Friable | *NESHAP Category | Sample Numbers Collected | Photo # | Laboratory Results | Asbestos Determination | Estimated Quantity |
|---|---|---|---|---|---|---|---|---|---|---|
| 31 | Caulking | Gray Caulking Sealant | Exterior Tank Area Located on North Side of Buildings | Non-Friable | Not Applicable | 31-1<br>31-2 | 31 | No Asbestos Detected | Non-ACM | Not Applicable |

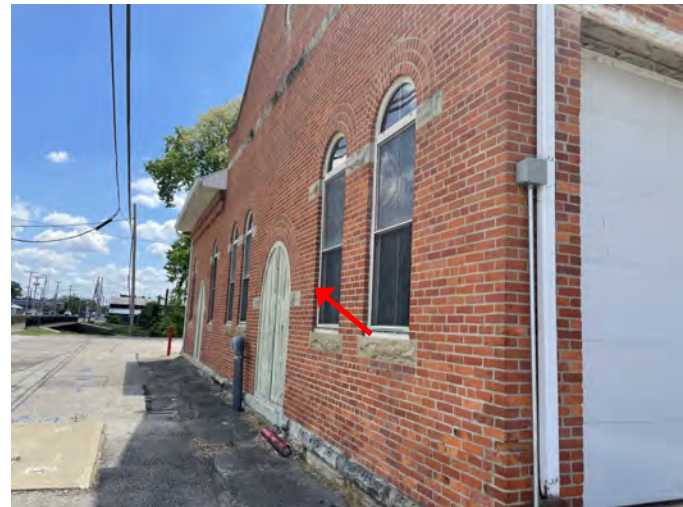
Photograph 32

| HA ID # | Material | Description | Locations of Material | *Friable or Non-Friable | *NESHAP Category | Sample Numbers Collected | Photo # | Laboratory Results | Asbestos Determination | Estimated Quantity |
|---|---|---|---|---|---|---|---|---|---|---|
| 32 | Caulking | Off-White Caulking Associated with Newer Windows | Various Exterior Windows of South Building | Non-Friable | Not Applicable | 32-1<br>32-2 | 32 | No Asbestos Detected | Non-ACM | Not Applicable |

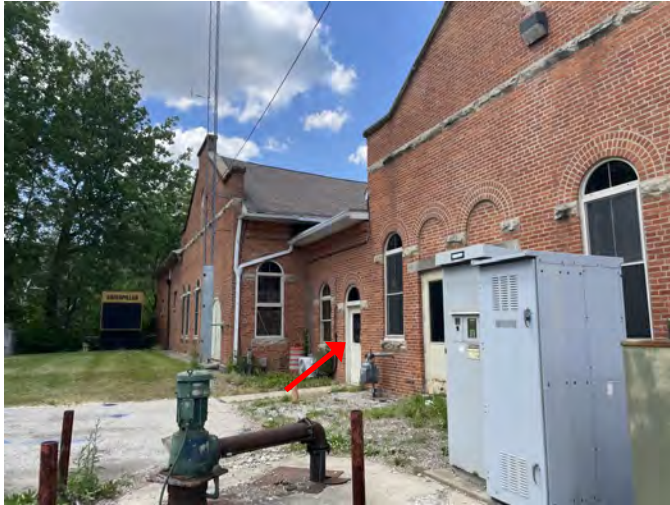
Photograph 33

| HA ID # | Material | Description | Locations of Material | *Friable or Non-Friable | *NESHAP Category | Sample Numbers Collected | Photo # | Laboratory Results | Asbestos Determination | Estimated Quantity |
|---|---|---|---|---|---|---|---|---|---|---|
| 33 | Caulking | Off-White Caulking Associated with Doors | Various Exterior Doors of South Building | Non-Friable | Not Applicable | 33-1<br>33-2 | 33 | No Asbestos Detected | Non-ACM | Not Applicable |

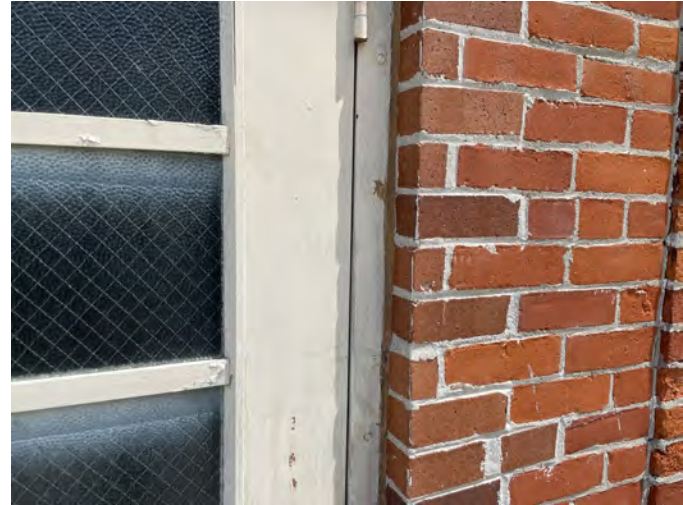
Photograph 34

| HA ID # | Material | Description | Locations of Material | *Friable or Non-Friable | *NESHAP Category | Sample Numbers Collected | Photo # | Laboratory Results | Asbestos Determination | Estimated Quantity |
|---|---|---|---|---|---|---|---|---|---|---|
| 34 | Caulking | Brown and Gray Caulking Associated with Door | Exterior Door, West Side of Building | Non-Friable | Not Applicable | 34-1<br>34-2 | 34 | No Asbestos Detected | Non-ACM | Not Applicable |

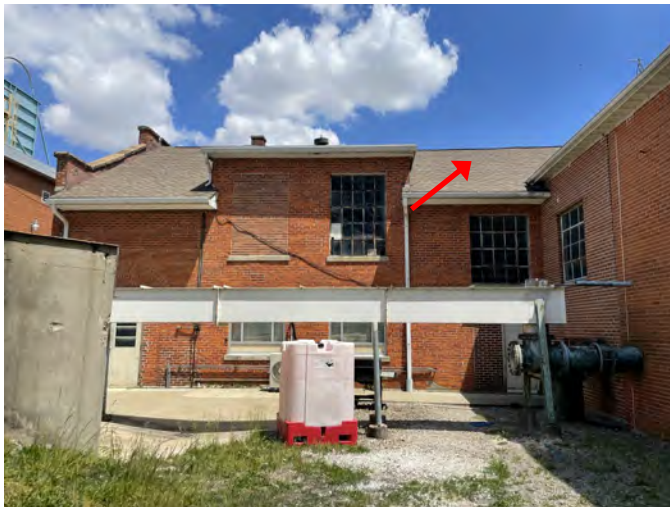
Photograph 35

| HA ID # | Material | Description | Locations of Material | *Friable or Non-Friable | *NESHAP Category | Sample Numbers Collected | Photo # | Laboratory Results | Asbestos Determination | Estimated Quantity |
|---|---|---|---|---|---|---|---|---|---|---|
| 35 | Roofing Materials | Roofing Materials - Various Types | Roof | Not Assessed - May Contain Asbestos | Not Assessed - May Contain Asbestos | No Samples | 35 | Not Assessed - May Contain Asbestos | Not Assessed - May Contain Asbestos | Not Assessed - May Contain Asbestos |

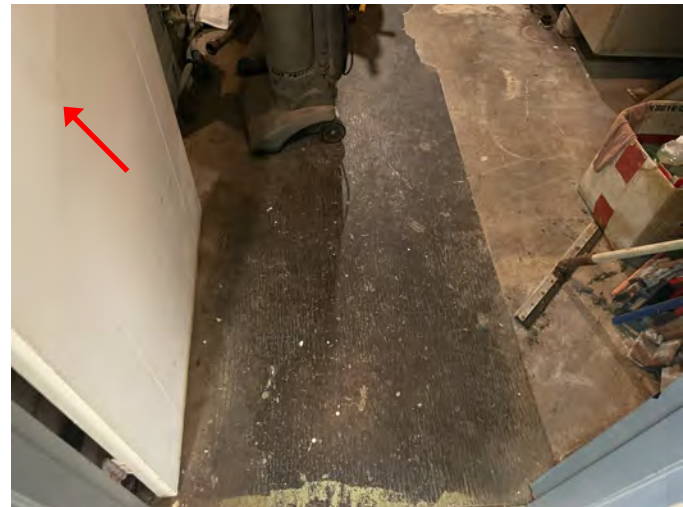
Photograph 36

| HA ID # | Material | Description | Locations of Material | *Friable or Non-Friable | *NESHAP Category | Sample Numbers Collected | Photo # | Laboratory Results | Asbestos Determination | Estimated Quantity |
|---|---|---|---|---|---|---|---|---|---|---|
| 36 | Fire-Rated Doors | Fire-Rated Doors - Various Types | Various Locations Throughout Building | Not Assessed - May Contain Asbestos | Not Assessed - May Contain Asbestos | No Samples | 36 | Not Assessed - May Contain Asbestos | Not Assessed - May Contain Asbestos | Not Assessed - May Contain Asbestos |

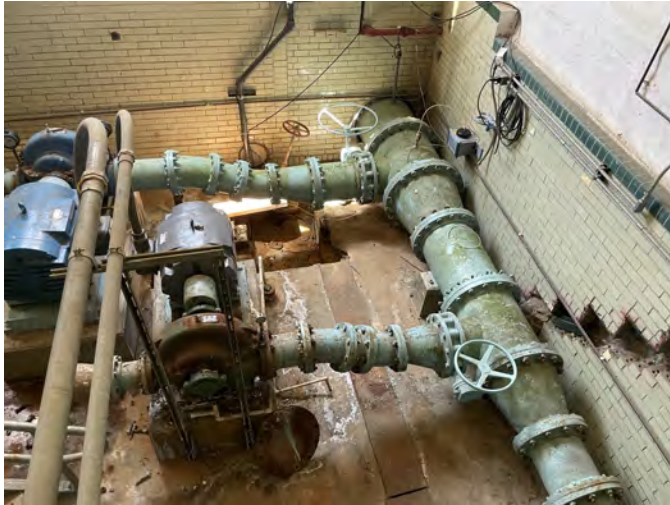
**Photograph 37**

| HA ID # | Material | Description | Locations of Material | *Friable or Non-Friable | *NESHAP Category | Sample Numbers Collected | Photo # | Laboratory Results | Asbestos Determination | Estimated Quantity |
|---|---|---|---|---|---|---|---|---|---|---|
| 37 | Gaskets and Packings | Gaskets and Packings - Various Types | Various Locations Throughout Building | Not Assessed - May Contain Asbestos | Not Assessed - May Contain Asbestos | No Samples | 37 | Not Assessed - May Contain Asbestos | Not Assessed - May Contain Asbestos | Not Assessed - May Contain Asbestos |

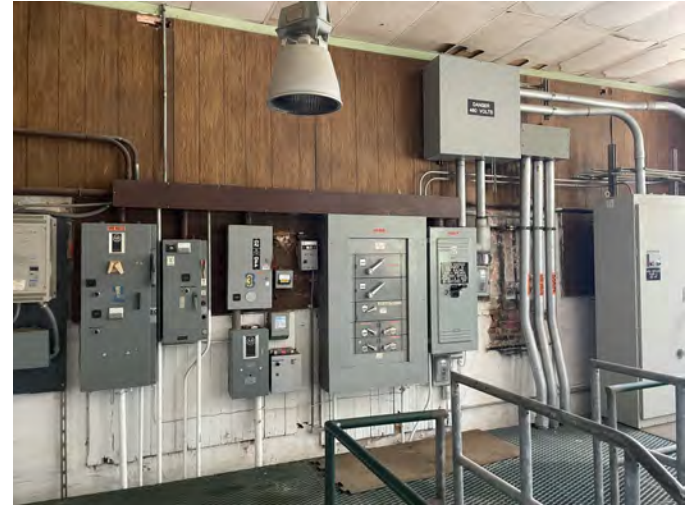
**Photograph 38**

| HA ID # | Material | Description | Locations of Material | *Friable or Non-Friable | *NESHAP Category | Sample Numbers Collected | Photo # | Laboratory Results | Asbestos Determination | Estimated Quantity |
|---|---|---|---|---|---|---|---|---|---|---|
| 38 | Electrical Systems Components | Electrical Systems Components - Various Types | Various Locations Throughout Building | Not Assessed - May Contain Asbestos | Not Assessed - May Contain Asbestos | No Samples | 38 | Not Assessed - May Contain Asbestos | Not Assessed - May Contain Asbestos | Not Assessed - May Contain Asbestos |

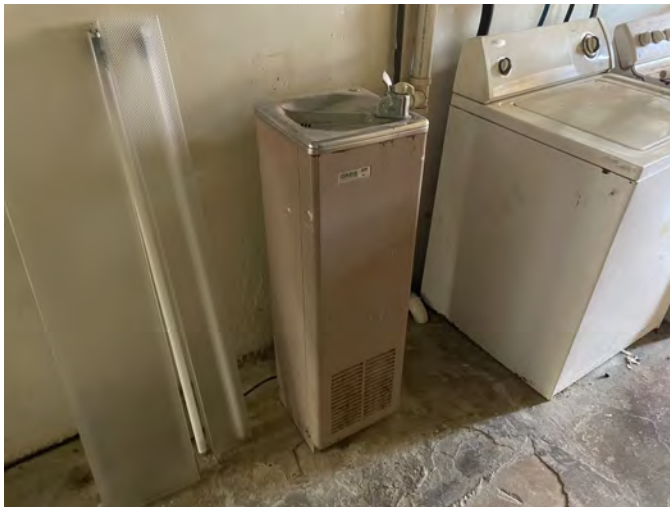
**Photograph 39**

| HA ID # | Material | Description | Locations of Material | *Friable or Non-Friable | *NESHAP Category | Sample Numbers Collected | Photo # | Laboratory Results | Asbestos Determination | Estimated Quantity |
|---|---|---|---|---|---|---|---|---|---|---|
| 39 | Drinking Fountain Tank Insulation | Drinking Fountain Tank Insulation | Various Locations Throughout Building | Not Assessed - May Contain Asbestos | Not Assessed - May Contain Asbestos | No Samples | 39 | Not Assessed - May Contain Asbestos | Not Assessed - May Contain Asbestos | Not Assessed - May Contain Asbestos |

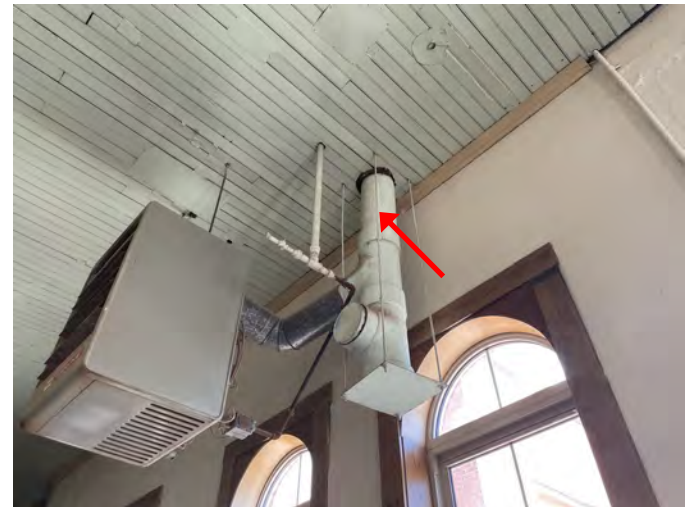
**Photograph 40**

| HA ID # | Material | Description | Locations of Material | *Friable or Non-Friable | *NESHAP Category | Sample Numbers Collected | Photo # | Laboratory Results | Asbestos Determination | Estimated Quantity |
|---|---|---|---|---|---|---|---|---|---|---|
| 40 | Gas Heater Exhaust Flue | Gas Heater Exhaust Flue | Various Locations Throughout Building | Not Assessed - May Contain Asbestos | Not Assessed - May Contain Asbestos | No Samples | 40 | Not Assessed - May Contain Asbestos | Not Assessed - May Contain Asbestos | Not Assessed - May Contain Asbestos |
