Asbestos Survey

370 E. Blagrove St.; Richwood, OH 43344

Union County Land Reutilization Corporation

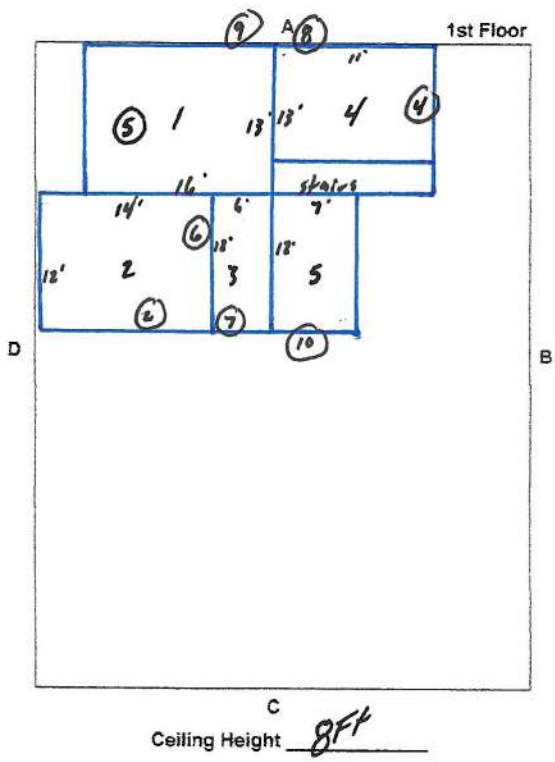
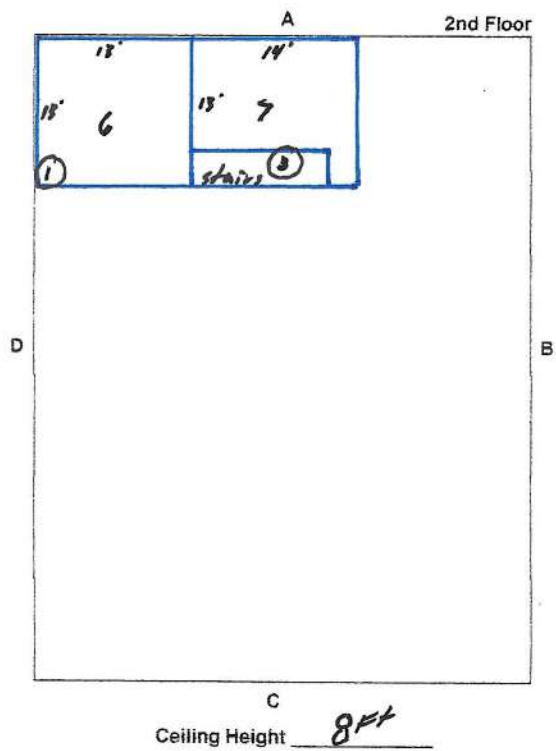
HA #	Material	Room Location	Color	Condition	Quantity
#1	Drywall/Compound	1, 2, 5, 6, 7	NA	G	2,100 SF
#2	Plaster	1-5, stairs	NA	G	2,130 SF
#3	Asphalt Roof	Roofing	Black	G	800 SF
#4	Transite Siding (under Vinyl/Wood)	Siding	white	G	2,000 SF
* Roofing can remain for demo

* 2 story house * Asphalt Roofing * Wood/Vinyl exterior
 * Vinyl Windows * Paneling * Plaster * Wood fiber ceiling tile No suspect
 * Drywall * Linoleum No suspect (Newer Foam)
 * Wood Window No suspect * Crawl * No suspect heating
 * Peel-n-stick No suspect * Metal Roofing over rooms 2, 3, 5
